# Manhole Inspection Summary

Manhole # S49GG\_032MH

Insp Date: **8/11/08 11:24 AM**

**Location** Address: **Biddle**

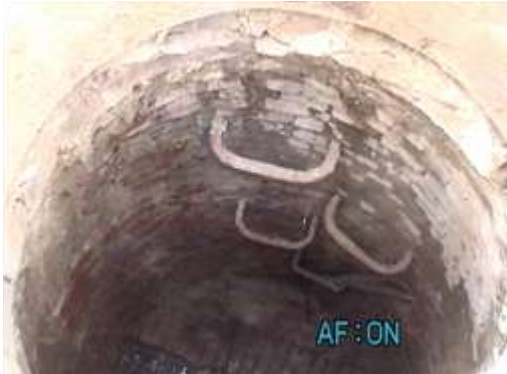
Defect 2

Infiltration: ☐ None ☐ Joint ☐ Cracks ☒ **Mortar** ☐ Roots ☐ Wall

Infiltration

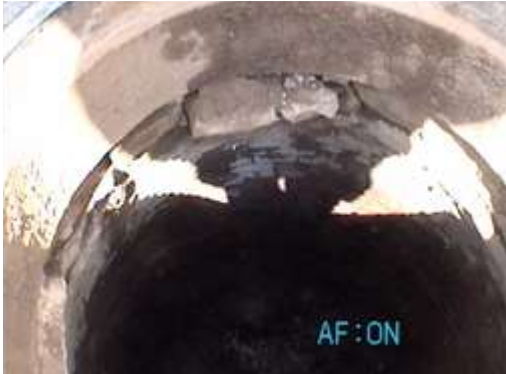
Defect 1

Condition: ☐ Sound ☐ Cracked ☐ Root Intrusion ☒ **Loose Brick** ☐ Deteriorated

loose brick

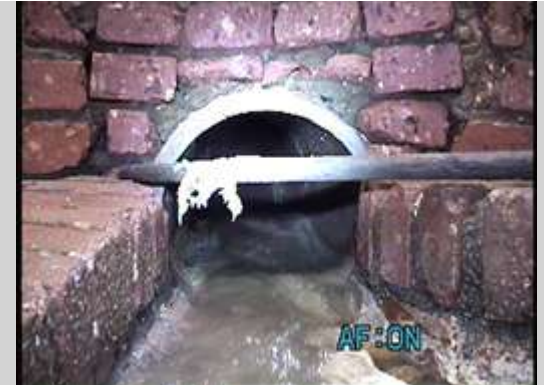
12 O'Clock Outflow

8 in. Circular Gravity Sewer  
Pipe Out @ 12 O'Clock

Infiltration: **None** Pipe Seal Cond: **Sound**

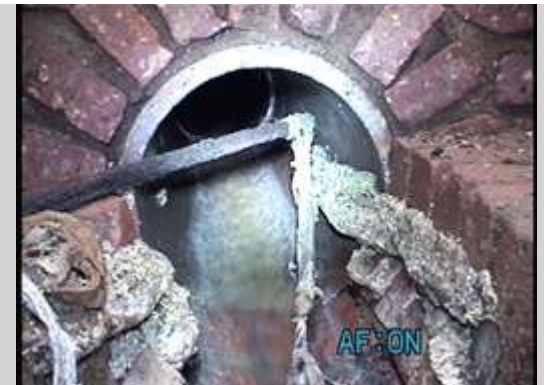
3 O'Clock Inflow

8 in. Circular Gravity Sewer  
Pipe In @ 3 O'Clock

Infiltration: **None** Pipe Seal Cond: **Sound**

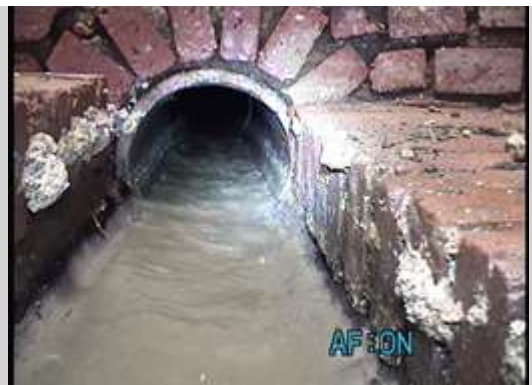
6 O'Clock Inflow

8 in. Circular Gravity Sewer

Pipe In @ 6 O'Clock

Infiltration: **None** Pipe Seal Cond: **Sound**
